Contradictions in the Conclusions, Science and Data in the UN OPCW Fact-Finding Mission Report S/1731/2019 on the Chlorine Cylinder Attack on 7 April 2018 in Douma, Syria

Theodore A. Postol

June 3, 2019, Palo Alto, California

This document provides a limited assessment of the 1 March 2019 OPCW Fact-Finding Mission Report S/1731/2019 on the alleged use of toxic chemicals in Douma, Syria on 7 April 2018. The OPCW report was provided to the UN Security Council on 1 March 2019.

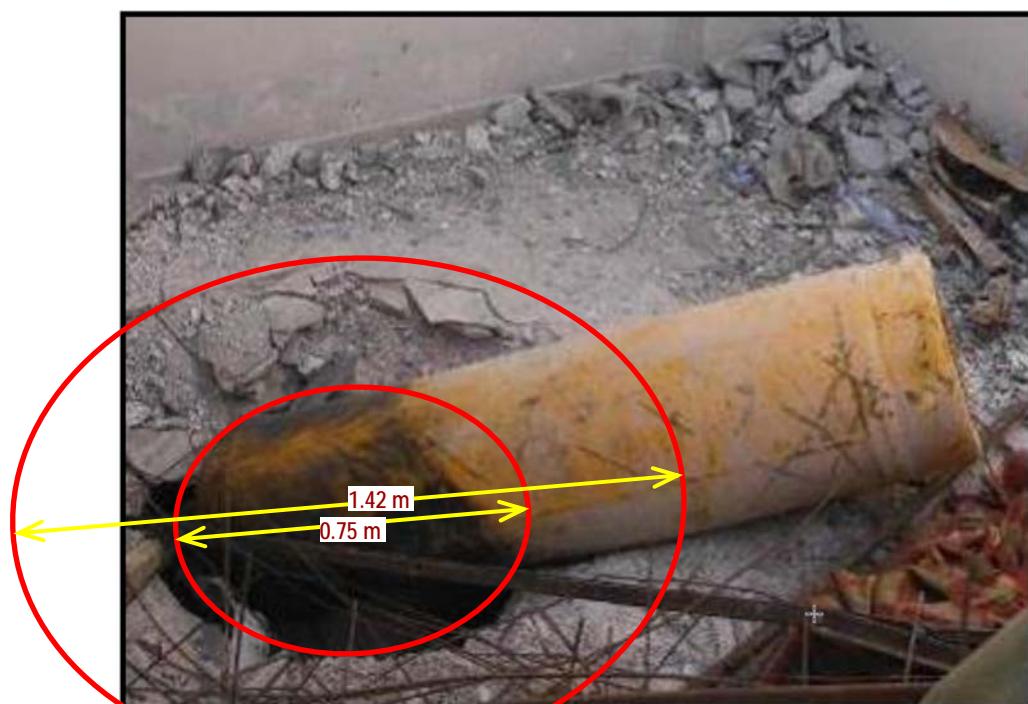
FIGURE A.6.2 CYLINDER WITH VISIBLE DAMAGE LIKELY ORIGINATING FROM THE MESH

Figure A.6.2 shown below from page 54 of the OPCW report S/1731/2019 shows the dimensions of the spallation radius of the hole that was supposedly produced by the impact of the chlorine cylinder in the photograph. The dimensions of the spallation radius were determined by scaling the already determined 0.75 m diameter of the tunneling hole, which was determined from a photograph of the underside of the crater at the top of the next page.

As can be seen from the photograph at the top of the next page, the diameter of the cylinder relative to the hole in the roof can be clearly seen from the room below. Since the cylinder diameter is known to be 0.4 m the diameter of the hole can be reasonably estimated by simply comparing the two diameters. By combining the information derived from the photograph from the room below with the information from the photograph above, we can determine the diameter of the spallation region on the surface of the roof.

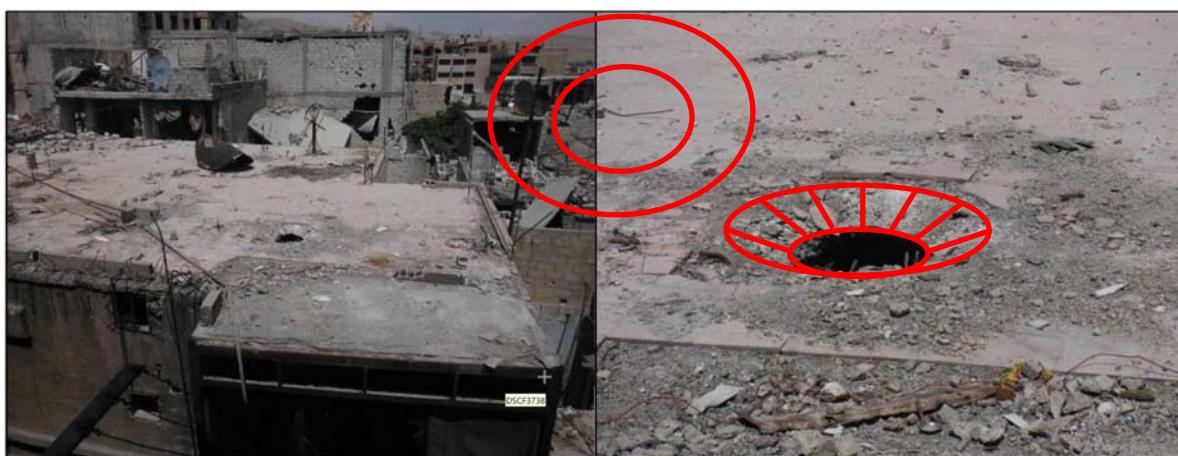
FIGURE A.6.3 ADJACENT ROOF SHOWING A CRATER SIMILAR TO THE ONE ON THE ROOF TERRACE AT LOCATION 2

The next photograph, figure A.6.3 from the top of page 55 in S/1713/2019 shows a photograph of the crater on the adjacent building. Inexplicably the report S/1713/2019 provides no information about the dimensions of this crater. This omission is itself an indication of serious problems with S/1713/2019. The provided photographs essentially ignore potentially informative information that could be used to get an estimate of the size of the crater.

We were able to take the measurements of the relative sizes of the diameters of the hole in the roof and the spallation area and project them over the crater after making minor adjustments for the non-vertical viewing

angle of the camera. As can be seen from the overlays of the crater, the ratio of the internal and external diameters of the crater on the adjacent building exactly matches the ratio of the internal and external diameters of the hole on the building that the OPCW report alleges was created by the impact of a chlorine cylinder.

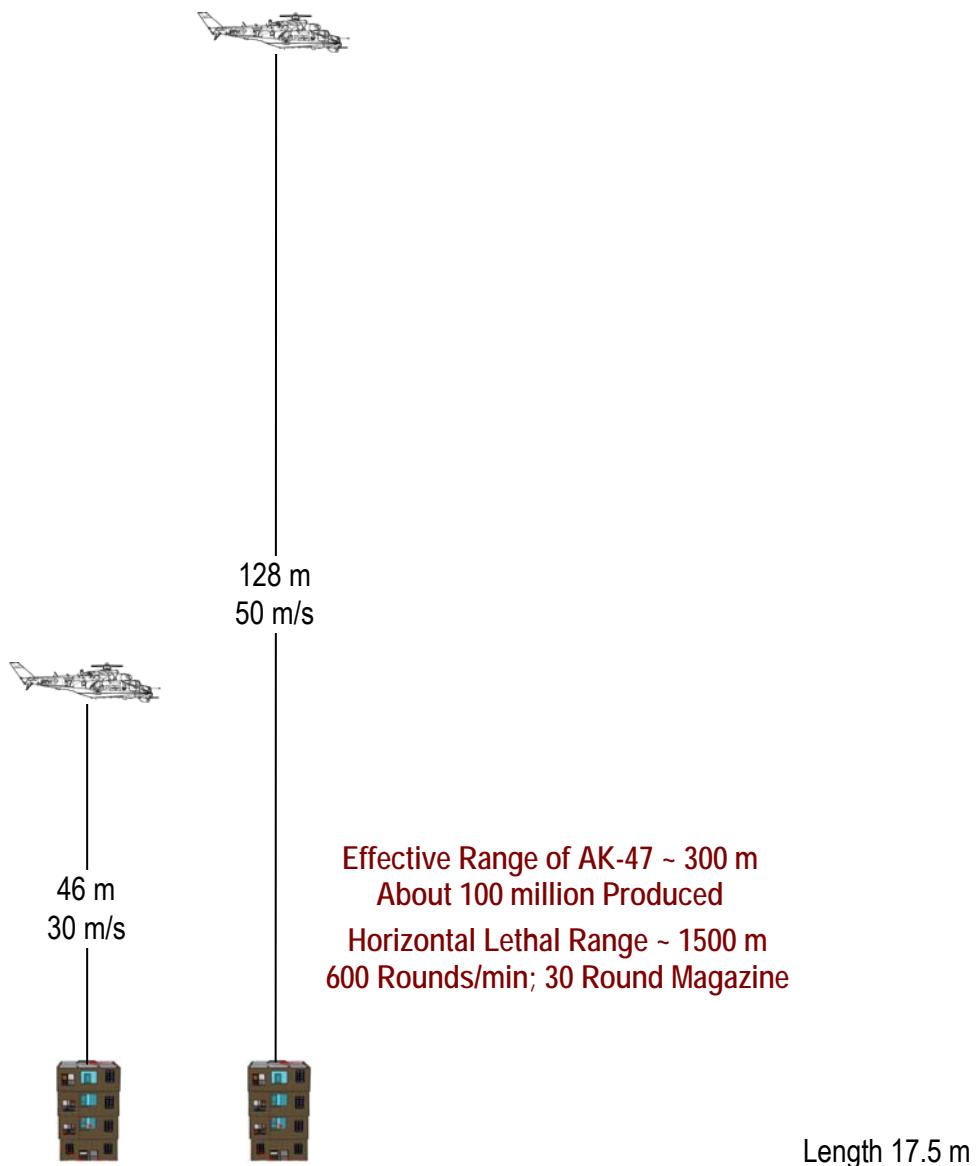
Impact Speeds of Chlorine Cylinders Dropped from Different Heights

Velocity at Impact (m/s)	Drop Altitude (m)	Drop Time (Seconds)
30	46	3
50	128	3
70	250	7
90	413	9
100	510	10

In particular, the assumed impact speed of the chlorine cylinder would have required that it be dropped from a helicopter at an altitude of between 50 and 250 m, with the most likely altitudes being between 50 and 130 m. At these altitudes helicopters would be highly vulnerable to ground fire from AK-47 assault rifles, or even hand guns – which are ubiquitous in these environments. Evidence from earlier studies of Syria's barrel bombing campaigns performed by my colleague Richard Lloyd indicate that the altitude used by Syrian helicopters is often close to about 2 km or higher. This choice of an operational altitude is consistent with procedures aimed at operating above altitudes where damage can occur from anti-aircraft fire from AK-47 assault rifle.
